Manhole Inspection Summary

Manhole # S330__012MH

Insp Date: **3/19/08 10:25 AM**

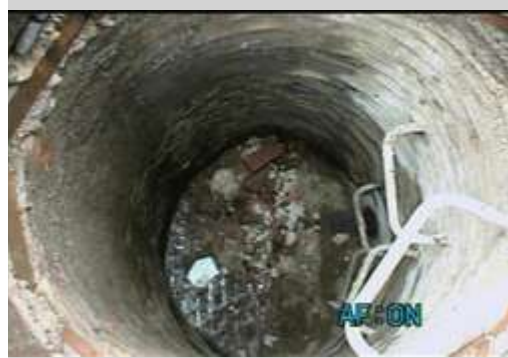
Top View

infiltration from frame, from 7 to 1

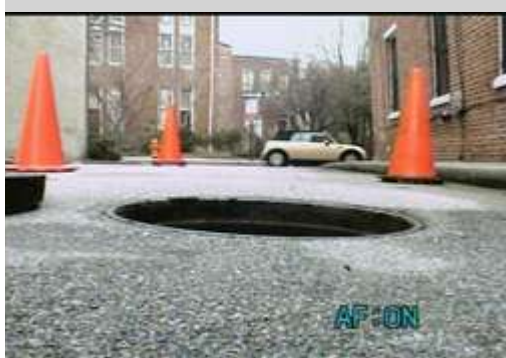
Miscellaneous

cover to grade -0.5"

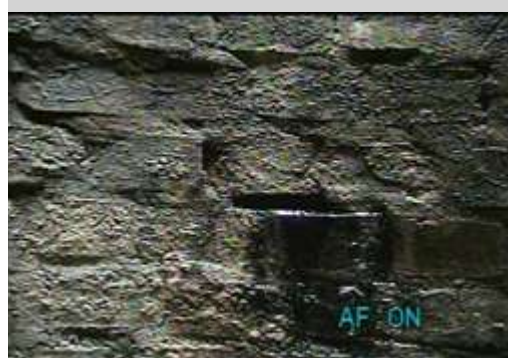
Defect 5

Condition: ☐ Sound ☐ Cracked ☐ Root Intrusion ☒ **Loose Brick** ☐ Deteriorated

Infiltration: ☐ None ☐ Joint ☐ Cracks ☒ **Mortar** ☐ Roots ☐ Wall

loose bricks and infiltration in barrel

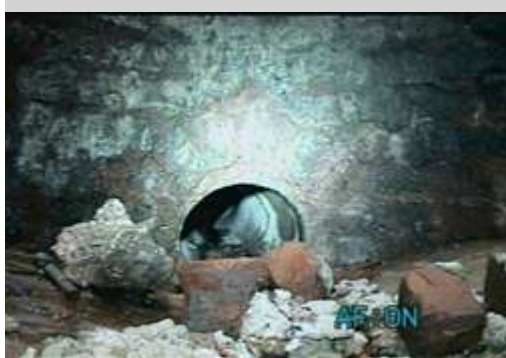
Defect 4

Condition: ☐ Sound ☐ Cracked ☐ Root Intrusion ☐ Deteriorated ☐ Leaks ☒ **Debris**

channel debris

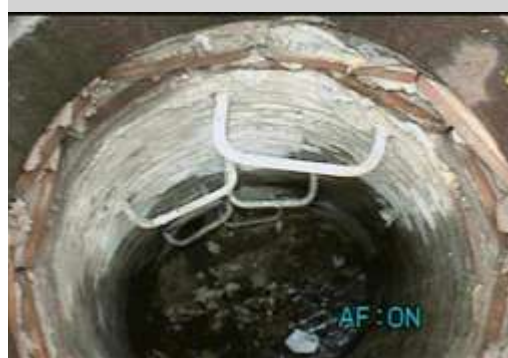
Defect 3

Condition: ☐ Sound ☒ **Cracked** ☐ Root Intrusion ☐ Loose Brick ☐ Deteriorated

Infiltration: ☐ None ☐ Joint ☒ **Cracks** ☐ Mortar ☐ Roots ☐ Wall

Steps Count: **5** Missing: **0** ☒ **Corroded**

chimney condition loose bricks, cracked, and corroded Steps

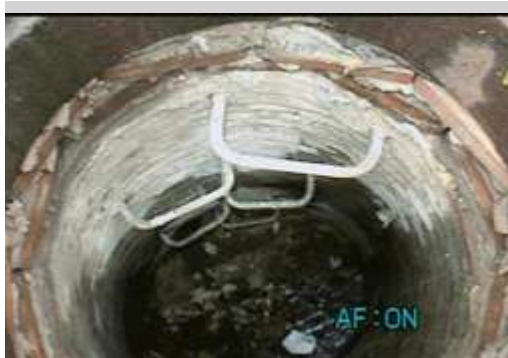
Defect 1

Frame Offset: **1** (in.) Condition: ☒ Sound ☐ Cracked ☐ Leaks

Offset
